Support Services for the Automotive Gas Turbine Project

Summary Report

Edited by
T. Golec
Chrysler Corporation
Detroit, Michigan 48288

April, 1981

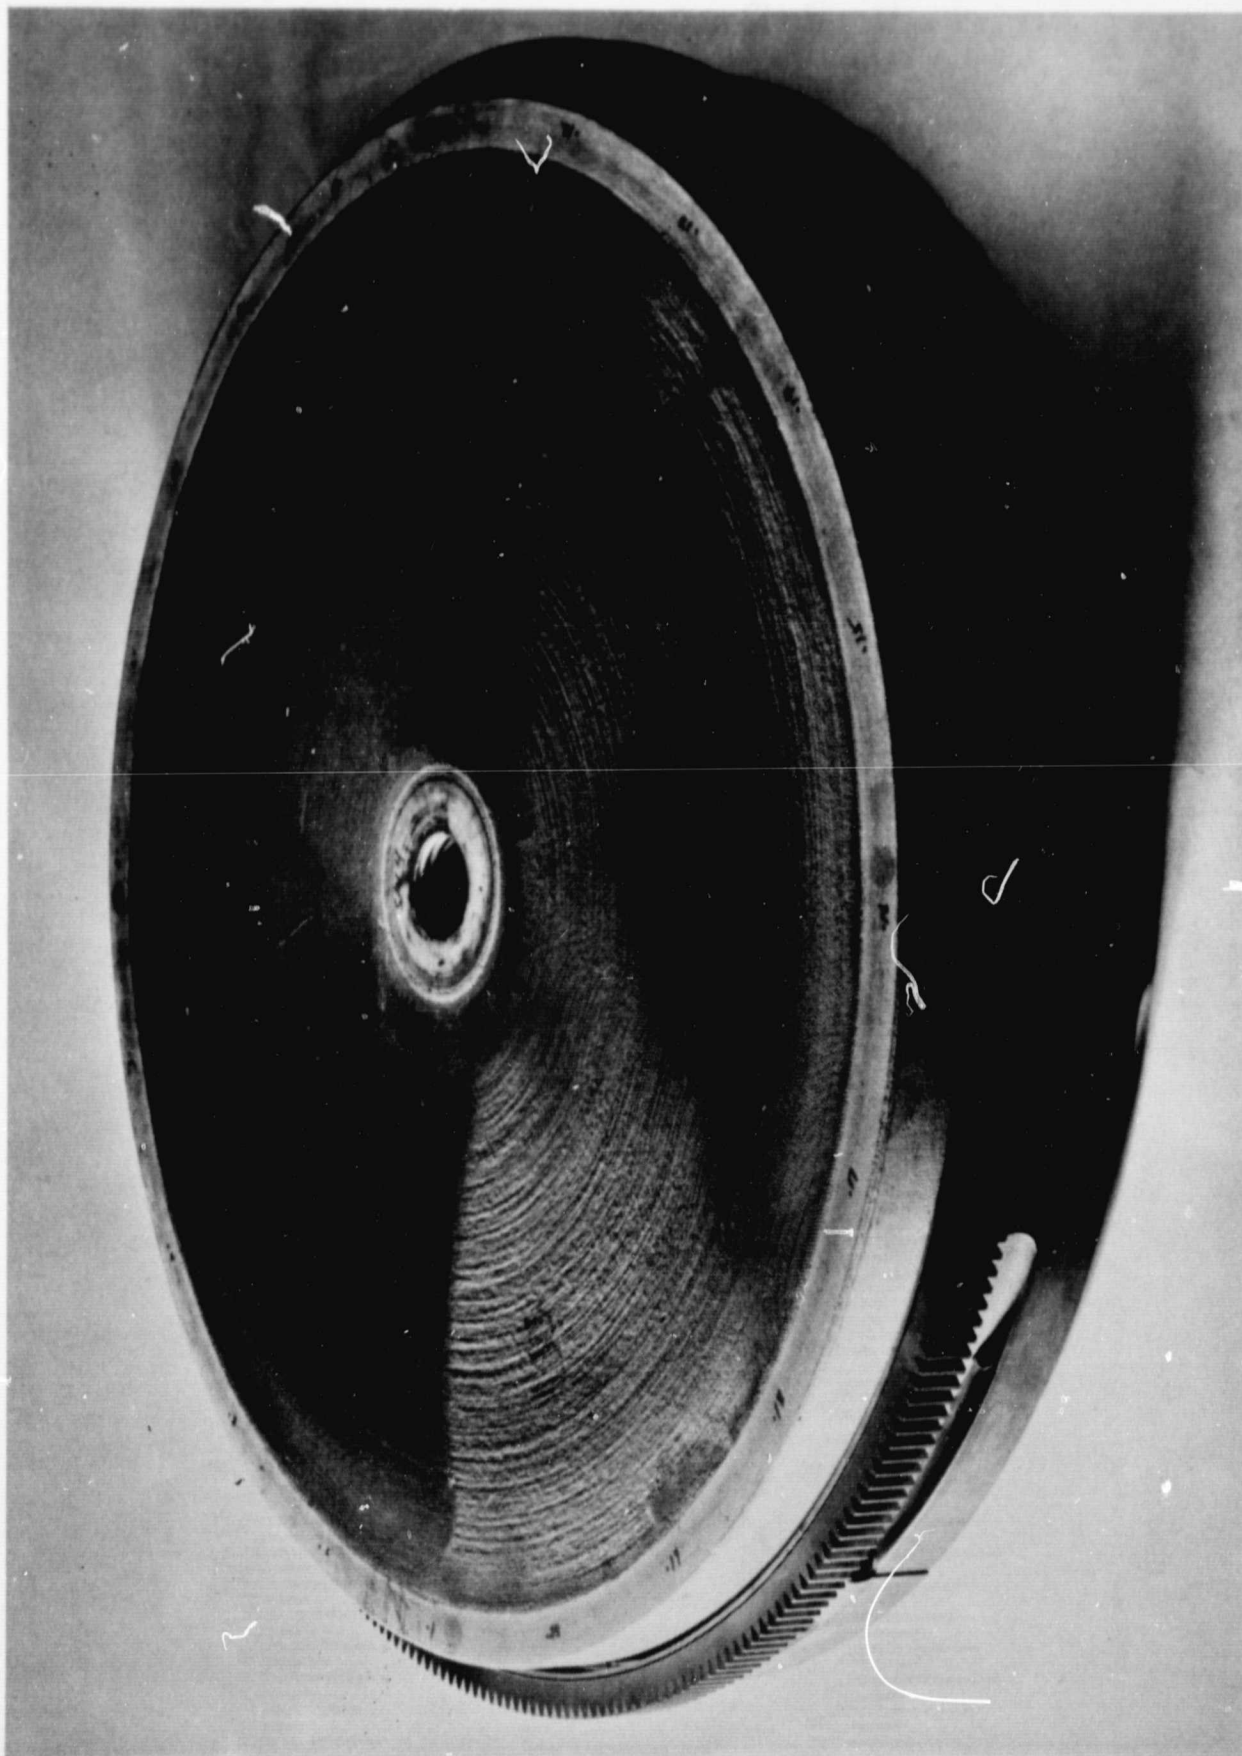
FIGURE 8a

Power Plant 2-3 was returned to Chrysler in May, 1979 for retrofit to the A926-1 configuration, and re-designation as PP 2-16. Total engine time was 359.4 hours. On teardown a number of discrepancies were found, including a glazed regenerator core, failed power turbine thrust bearing, and heavily rubbed PT rotor. These findings are documented in Appendix C (Failure Report No. 74) and related photographs, see Figures 8a through 8c.

GLAZED REGENERATOR CORE (TYPICAL)

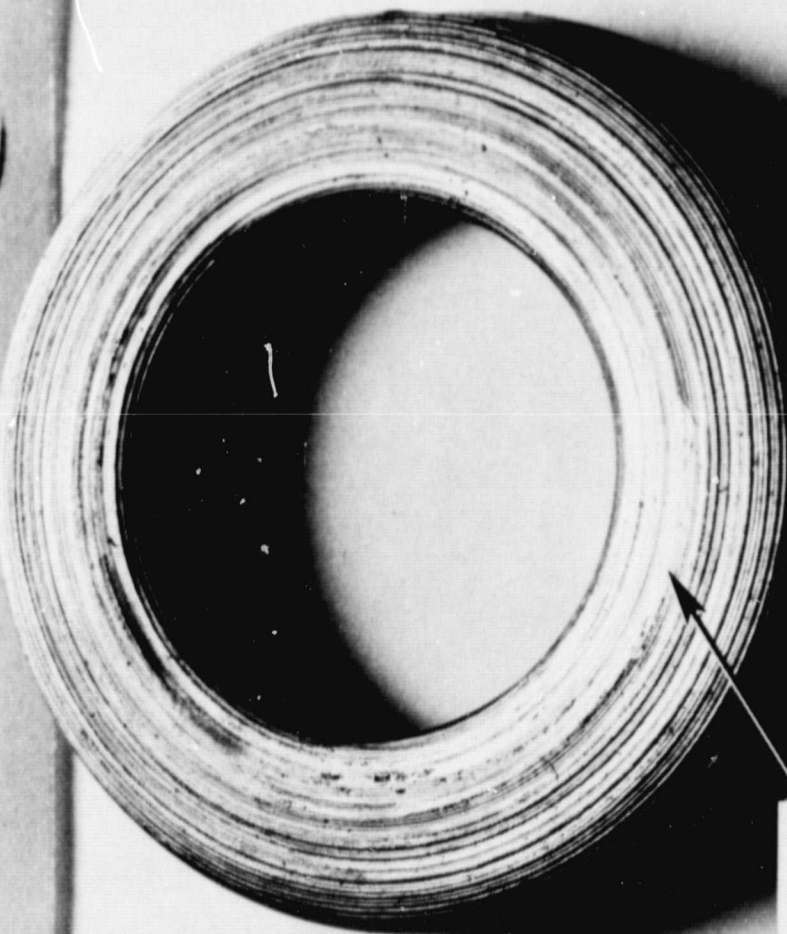
FIGURE 8b

THRUST FACE COMPLETELY
WORN

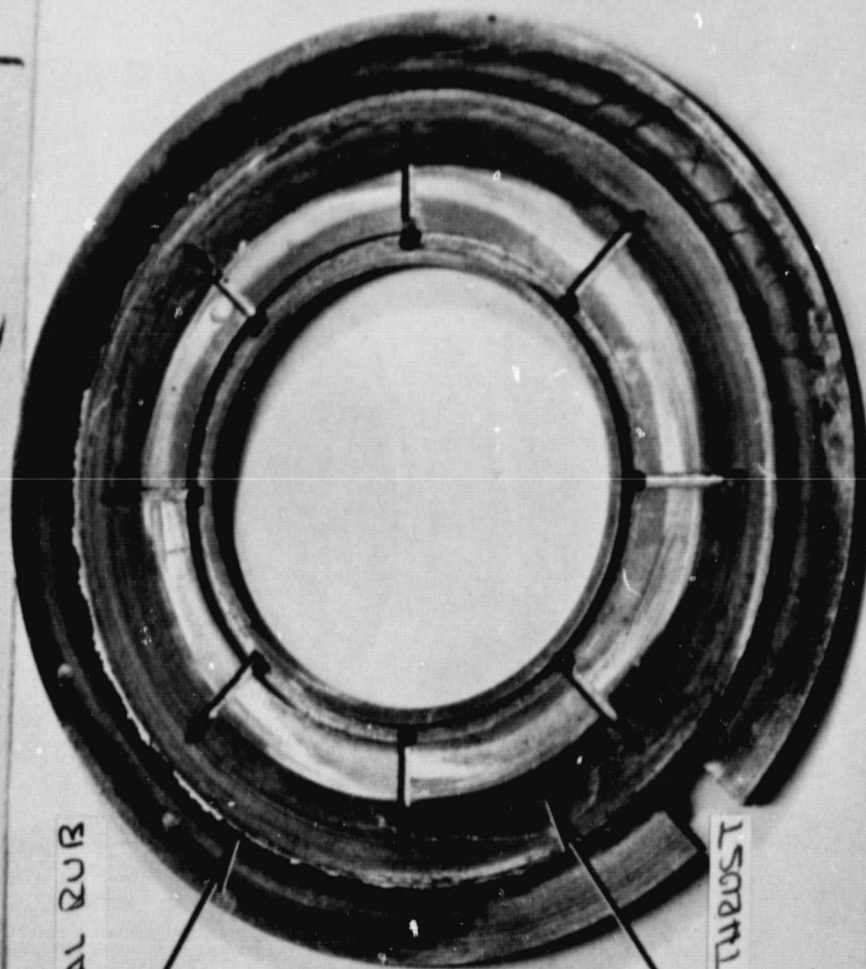
LOCAL LIGHT PERIPHERAL RUB

DISCOLORATION OF THRUST
FACE

ENGINE 3, FAILED ANTI-THRUST BEARING

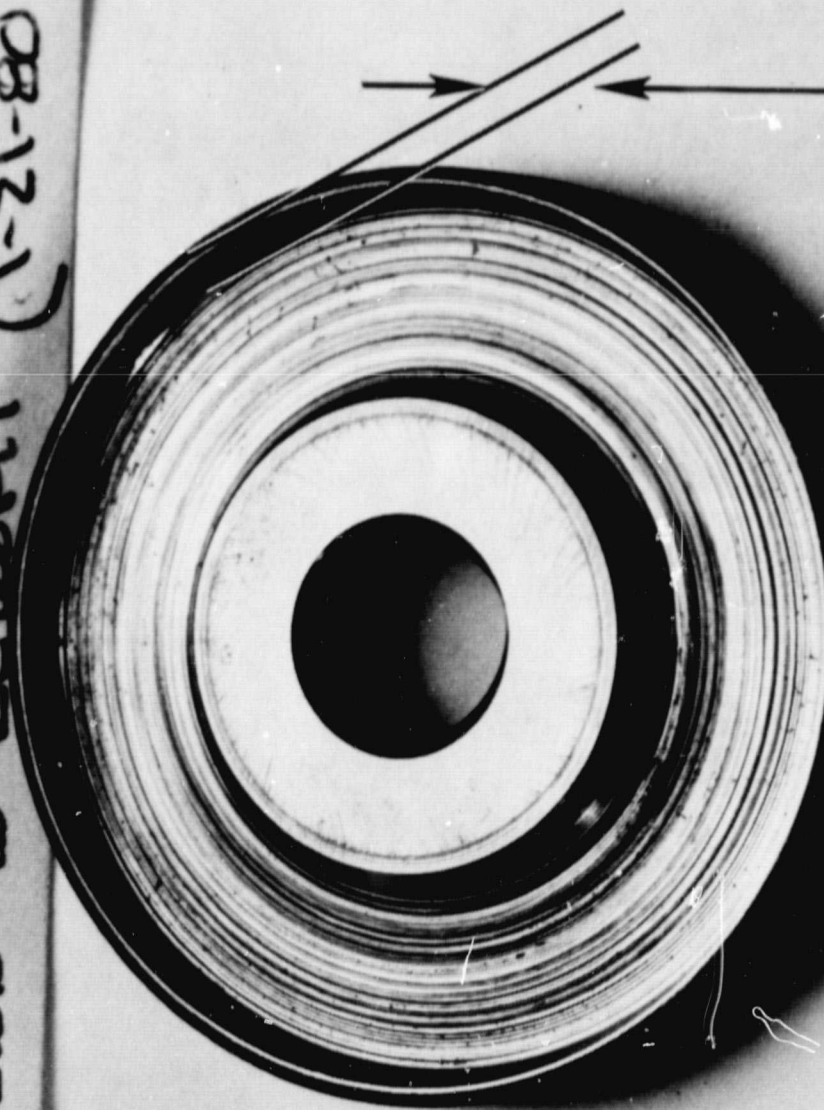
FIGURE 8d

THRUST FACE WIDTH 1/1.5 MM

ENGINE 3, FAILED THRUST PLATE

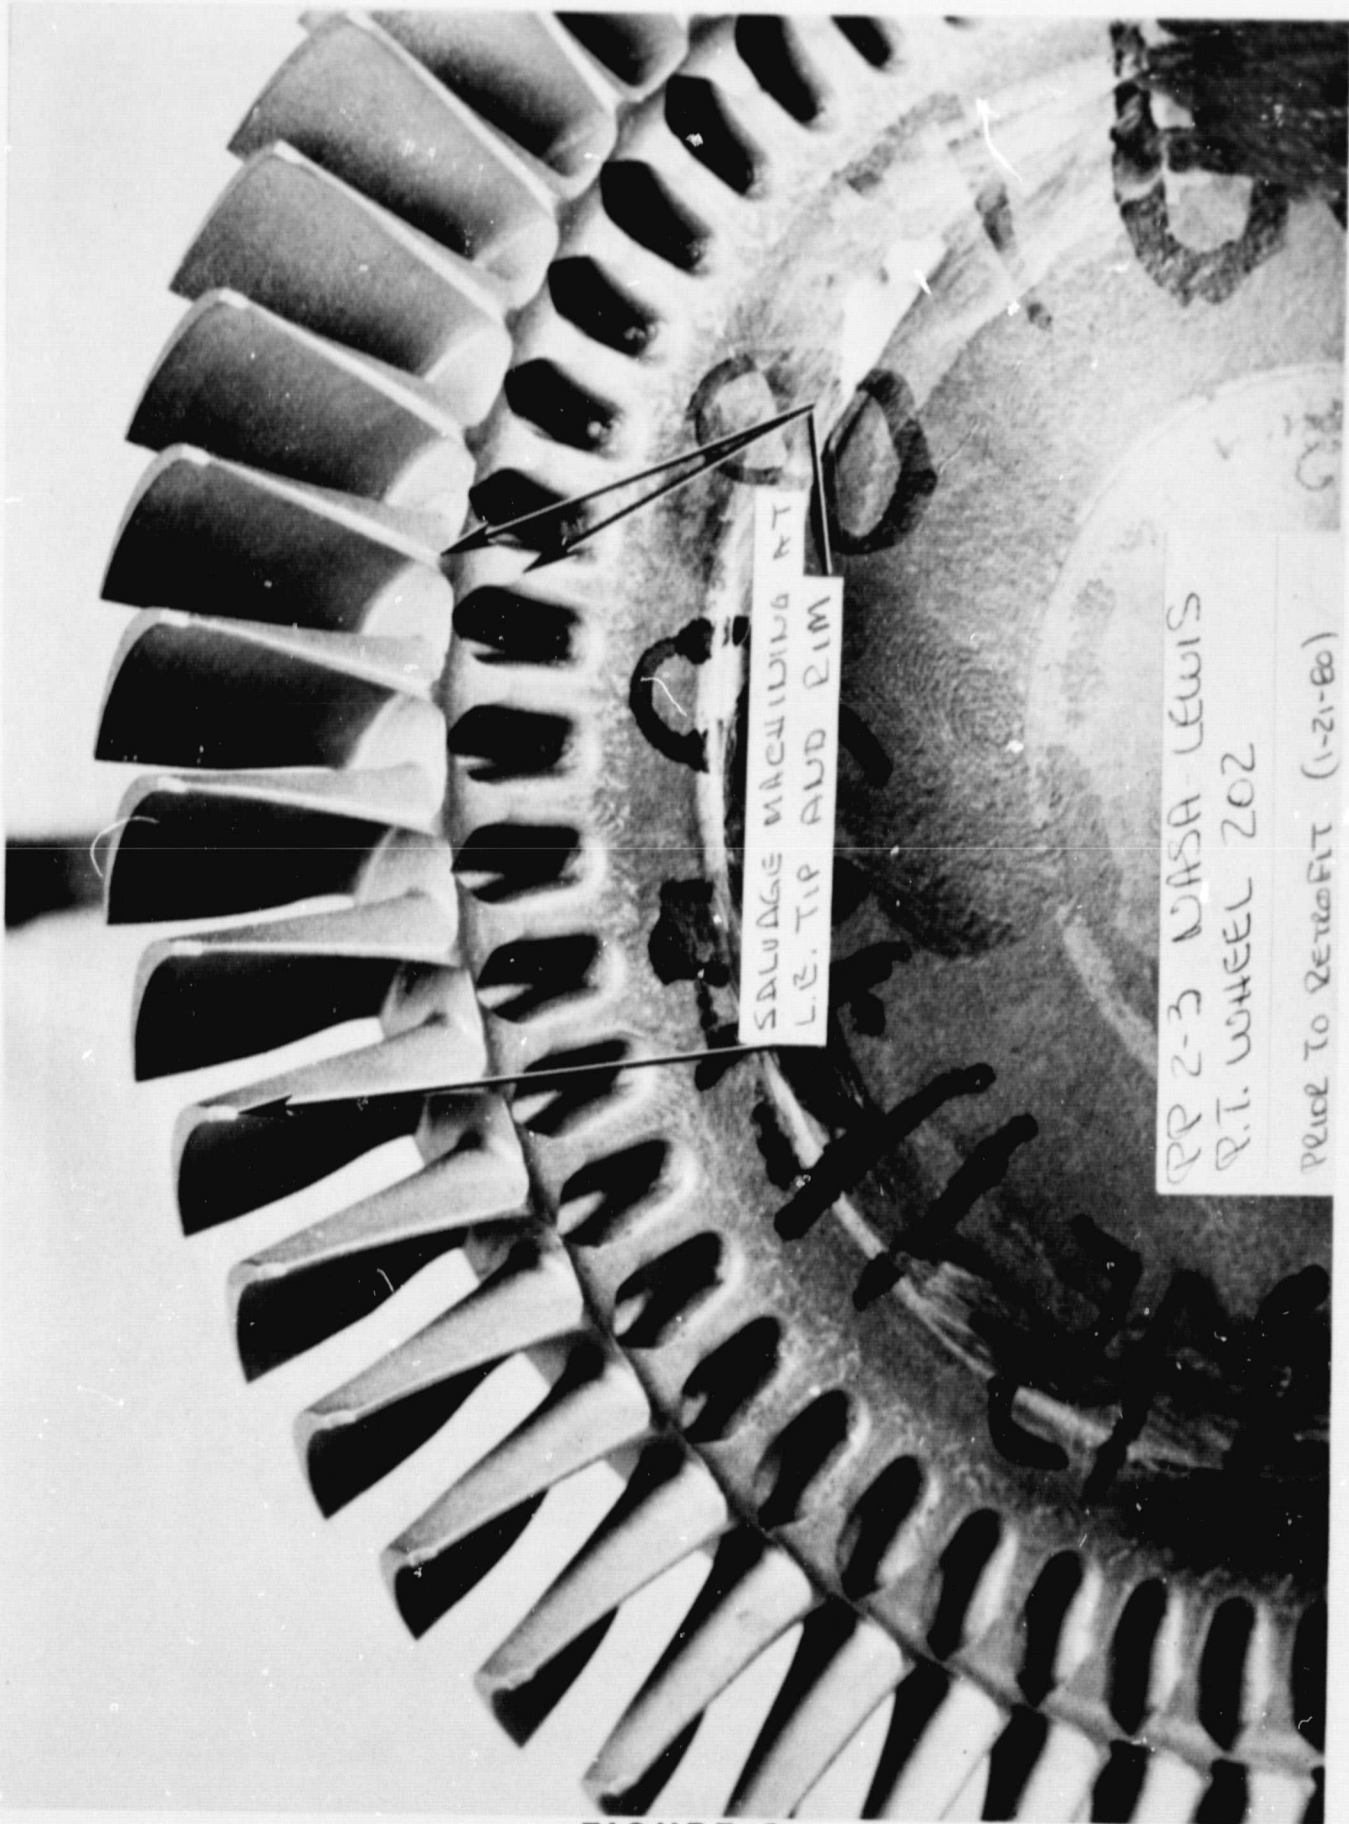
FIGURE 8.

ENGINE 3, POWER TURBINE ROTOR REPAIRS

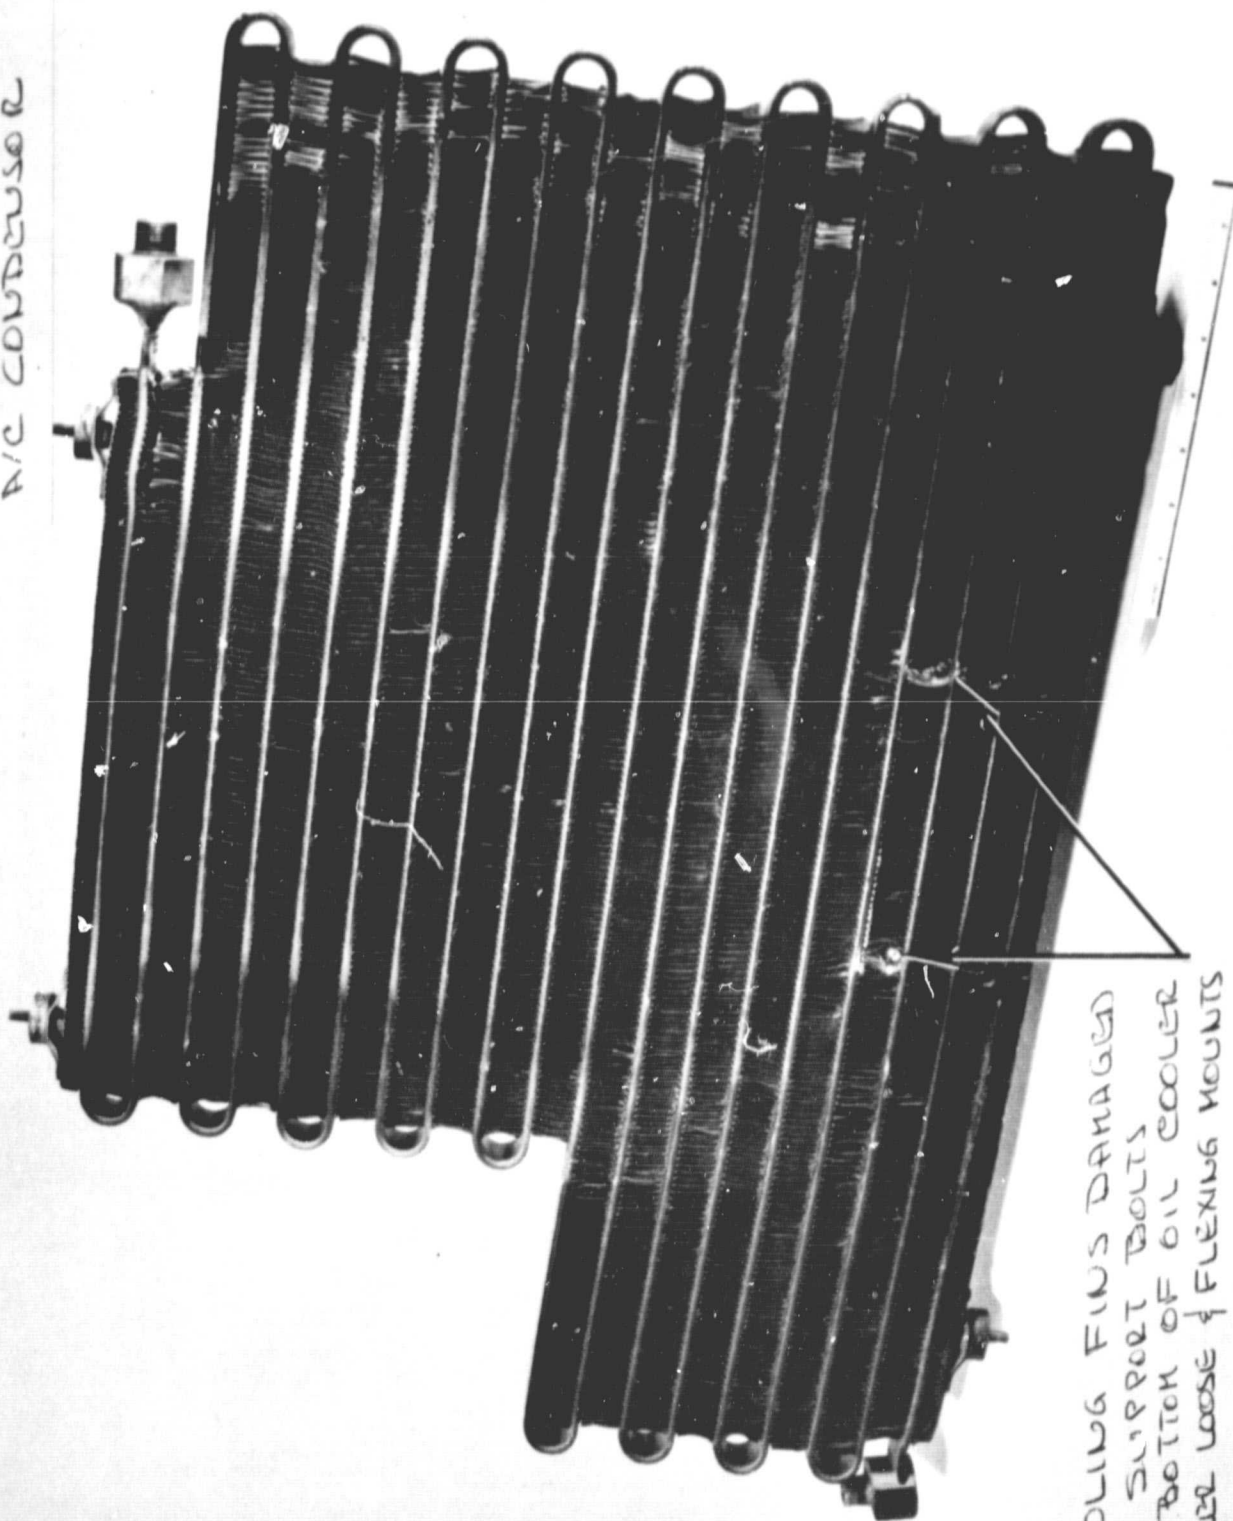
COOLING FINS DAMAGED
BY SUPPORT BOLTS
ON BOTTOM OF OIL COOLER
COOLER LOOSE & FLEXING MOUNTS

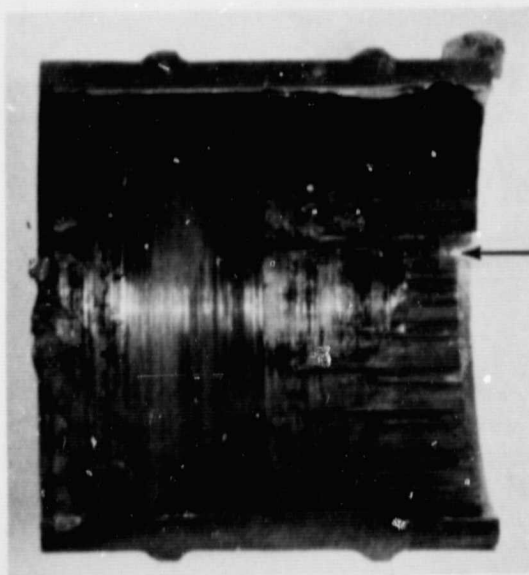
Figure 3.

Top edge deformation

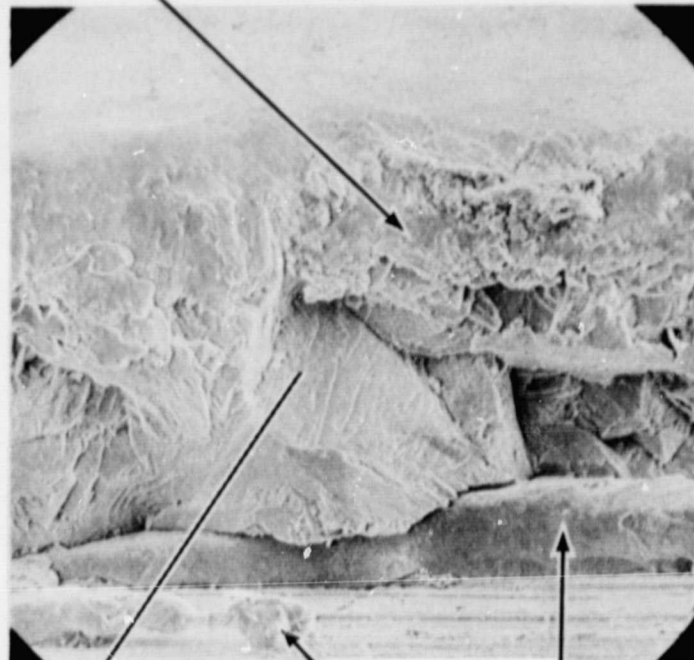
Figure 6.

Weld
Expulsion

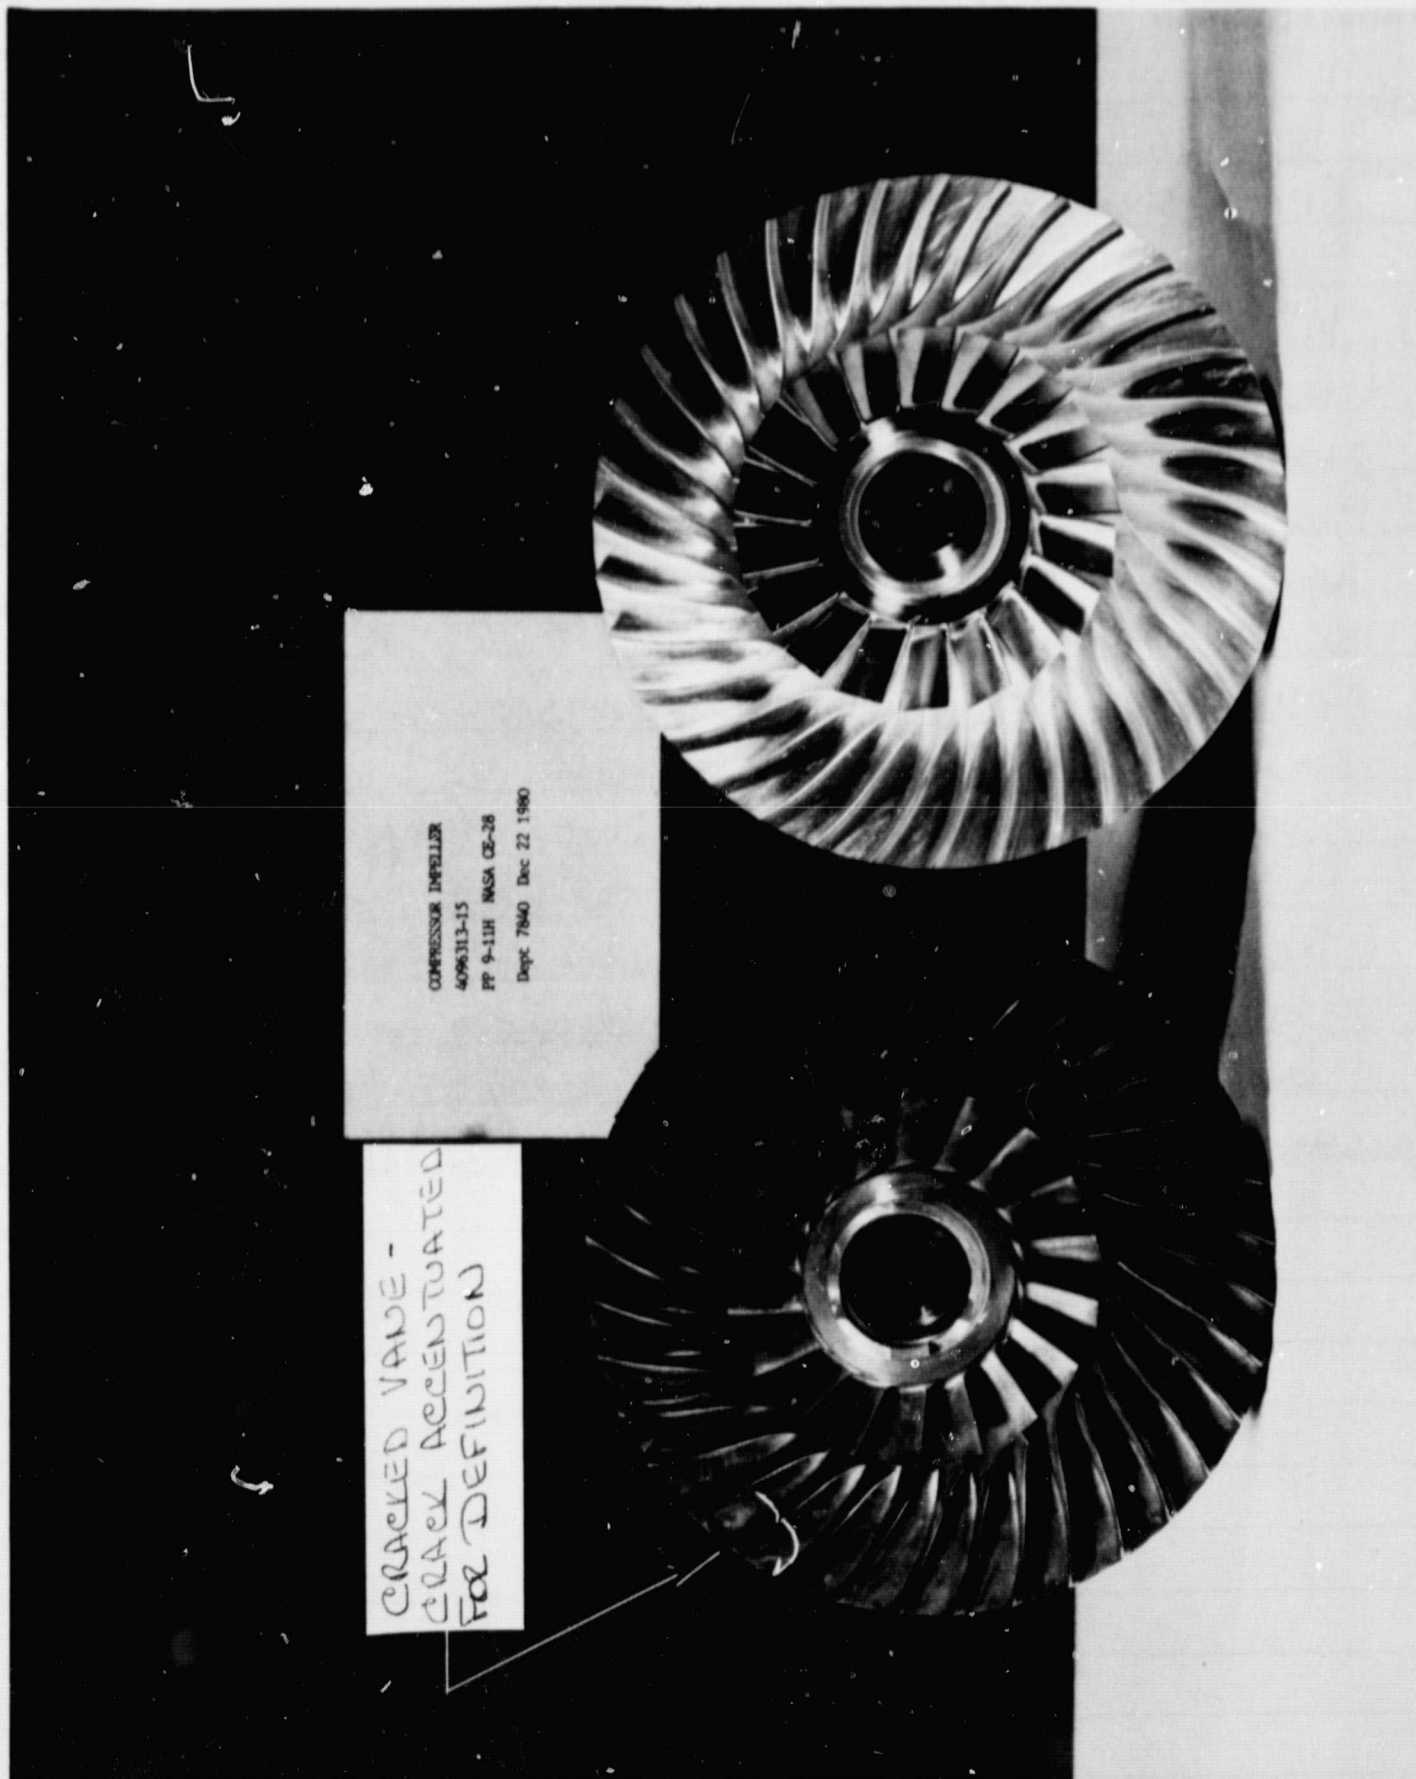
CRACKED VAUVE -
CRACK ACCENTUATED
FOR DEFINITION

COMPRESSOR IMPELLER
4096313-15
PP 9-11H NASA CE-28
Dept 7840 Dec 22 1980

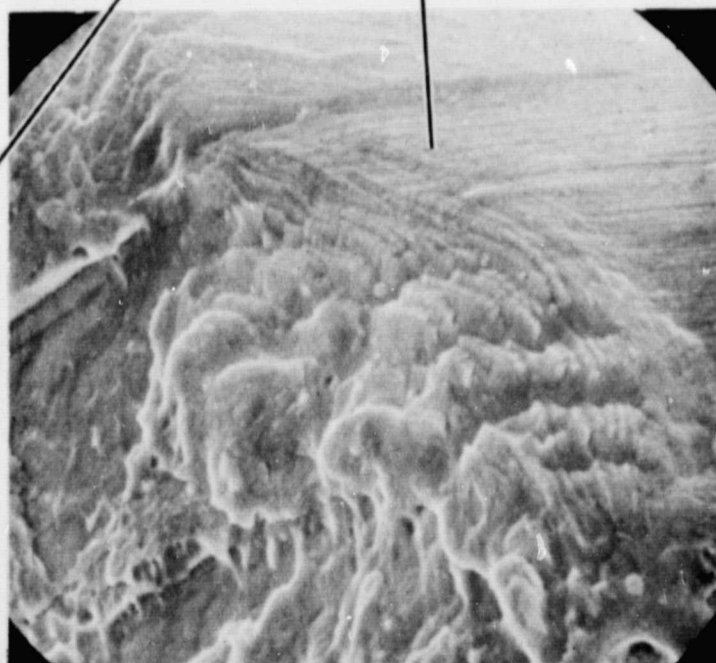
Figure 4 3000X
Fatigue Striations

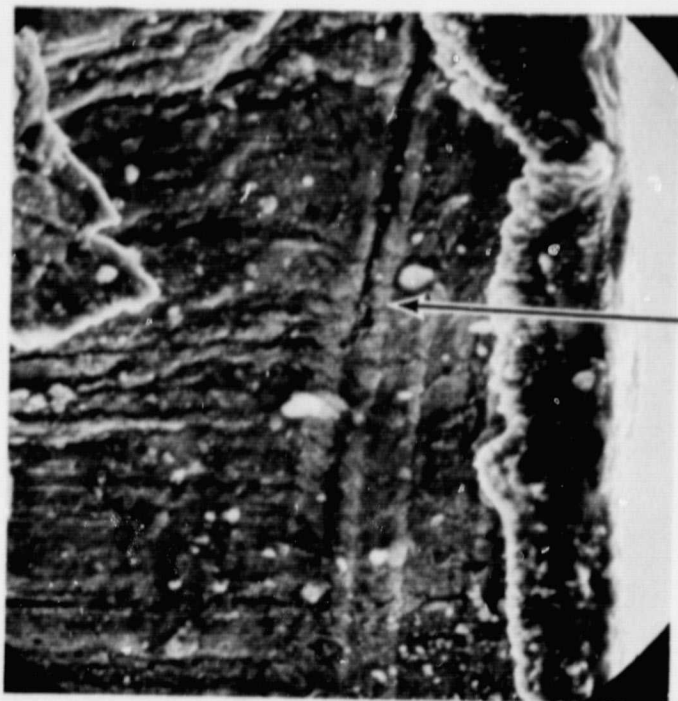
Figure 6 2000X
Fatigue Striations

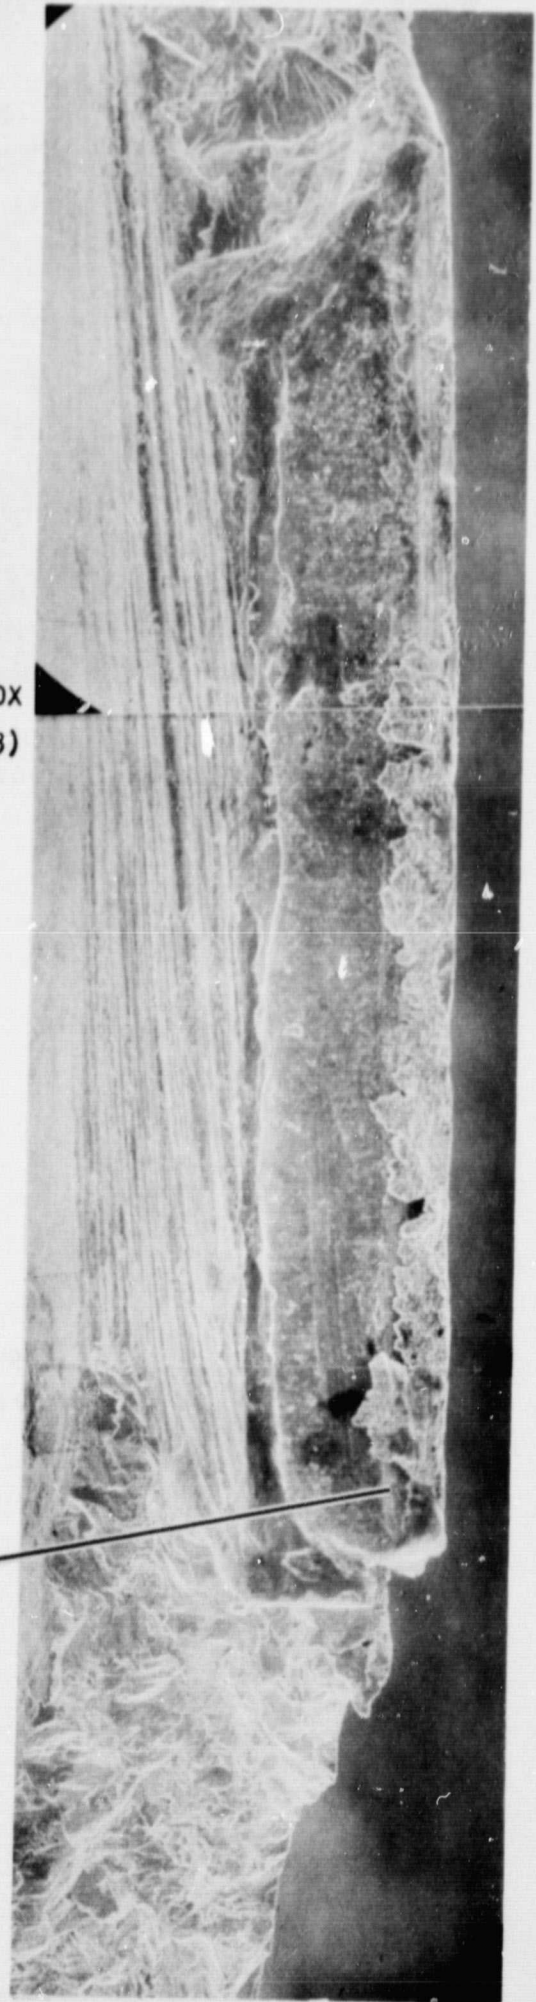
Figure 8 2000X
Fatigue Striations
